# **Terminal Facility Assessment**

### FINAL

Version 2.0 August 12, 2022 Toledo-Lucas County Port Authority Eugene F. Kranz Toledo Express Airport Swanton, Ohio RS&H No.: 218-1858-012

Prepared by RS&H Ohio, Inc. at the direction of the Toledo-Lucas County Port Authority

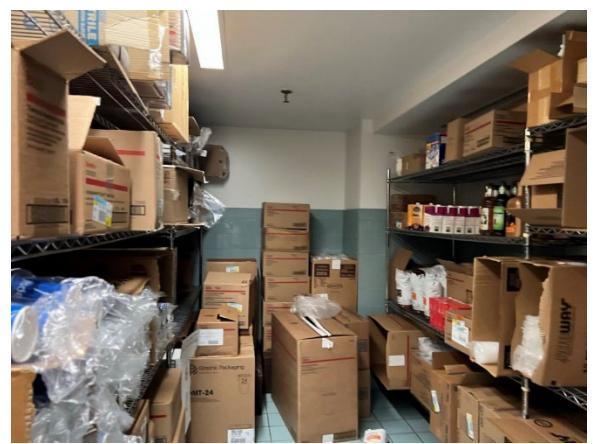
FIGURE 10 – CONCESSIONS STORAGE

- TSA breakroom is missing basic amenities such as a kitchenette
- Concession storage is small, resulting in the use of adjacent unused hallways, see Figure 10

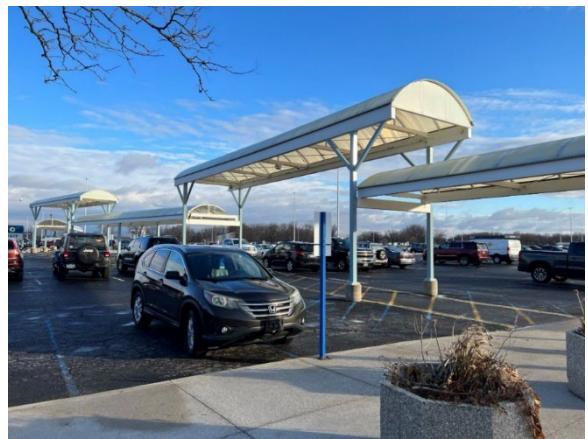
FIGURE 20 - CANOPY FACING PARKING LOT

It was observed during heavy rainfall that the canopy leading to the parking lot did not provide any protection from the rain.

• The width of the canopy should be wider so that there is some protection from the elements.

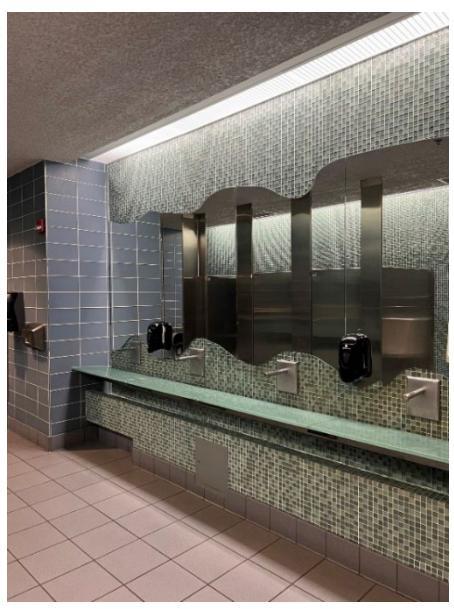
FIGURE 23 – AIRSIDE PUBLIC RESTROOM

Although the Airside Restrooms are newer construction, the Building Engineer stated there are issues with the faucets. The design of the faucets is not intuitive for users, and people try to rotate them. Parts are loosened, and leaks result.

• This will be an ongoing maintenance issue until faucets are replaced.

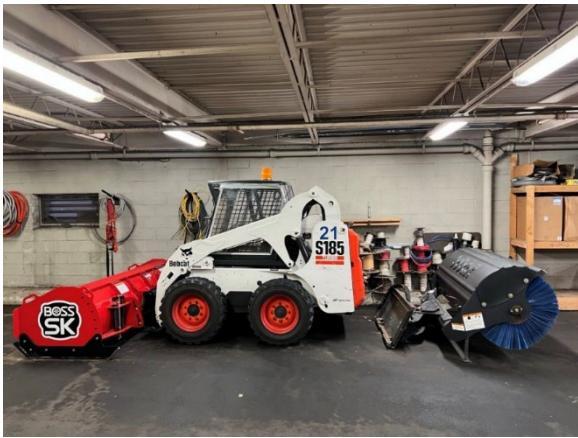
FIGURE 24 – SRE EQUIPMENT

Snow Removal Equipment (SRE) is often parked at the inbound baggage area, which causes congestion in that space. This suggests that the allocated space for the SRE is inadequate or not in a convenient location.

• SRE should have sufficient space central to the areas of use.

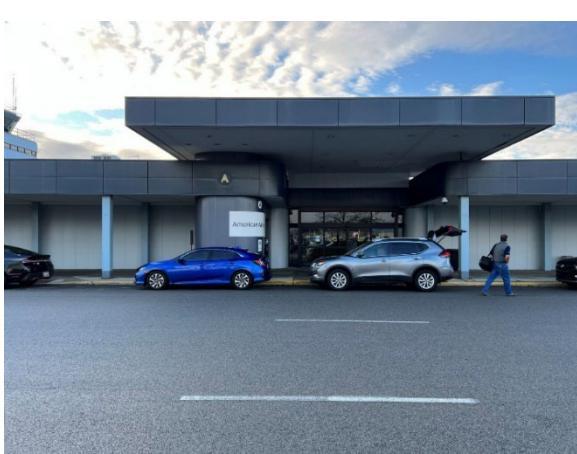
FIGURE 28 – PEDESTRIAN CROSSING FACING TERMINAL

The curb cuts with flared sides and pedestrian crossing pavement markings do not align with the entrances to the building. However, parking lot access areas are directly across from the entrances, marked for pedestrian traffic by bollards. It was noted that customers would proceed directly from the doors straight across to the parking lot. In doing so, the marked pedestrian pavement crosswalks were not being utilized.

• Pedestrian crossing pavement markings and curb cuts should be relocated so that foot traffic is crossing at those areas.

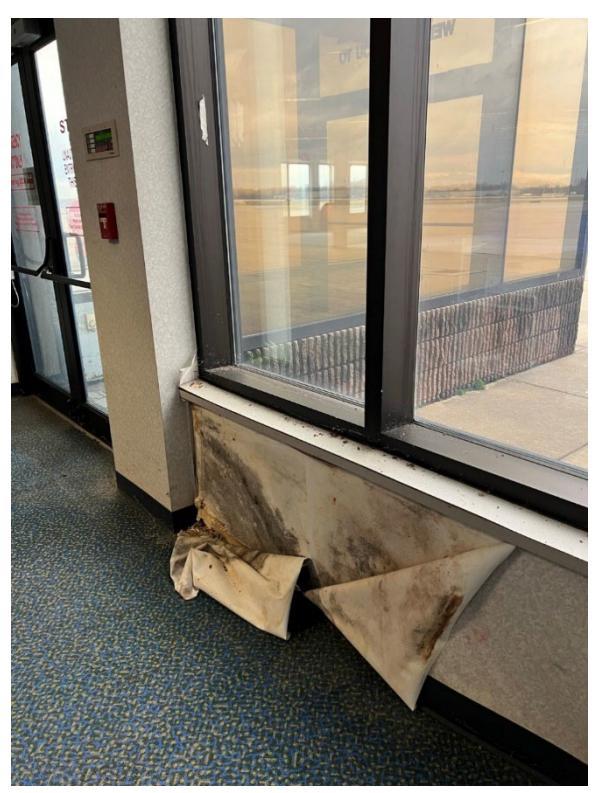
FIGURE 30 - MOLD IN EAST HOLDROOM

Mold is present in the East Holdroom. This is due to water infiltration at the exterior envelope. Blackwater retainage was found around the escalator pit in the East Holdroom.

• Due to mold and water infiltration issues, the East Holdroom, the West Corridor, and the associated stairs.

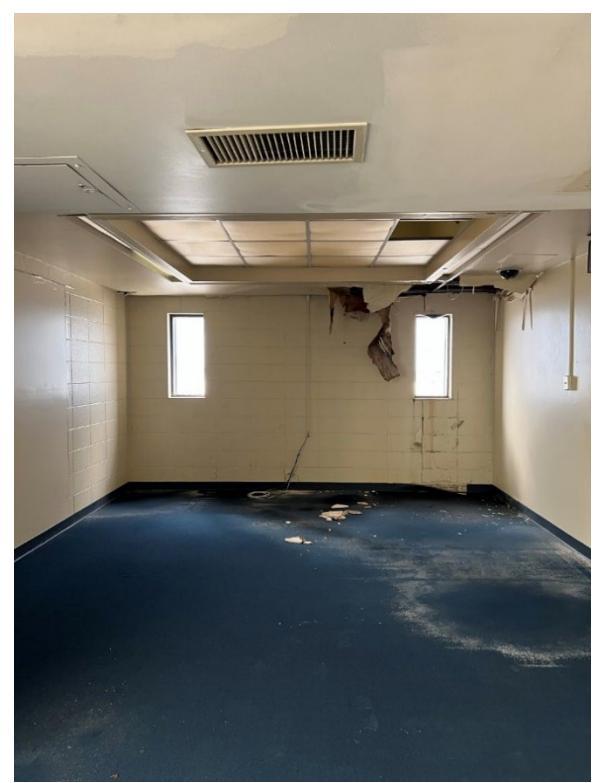
FIGURE 31 - WATER DAMAGE AT FORMER GATE 1

The west corridor and stairwell have sustained a lot of water damage. Although no signs of mold were noticed, the space had a strong, musty smell and is suspected of having mold in areas not visible during the walk-through.

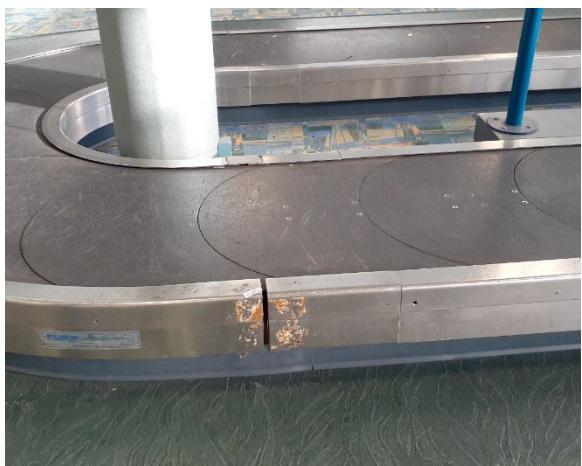
FIGURE 44 – BAGGAGE CONVEYOR PANEL GAP

The baggage conveyor is beyond its useful life. It had a belt that showed large worn, cracked areas and holes. There are misaligned gaps in the stainless steel that are open to potential injuries.

• The baggage conveyor system should be replaced. Sensors, card readers, associated overhead doors and other system components should all be replaced with a new baggage conveyor system.

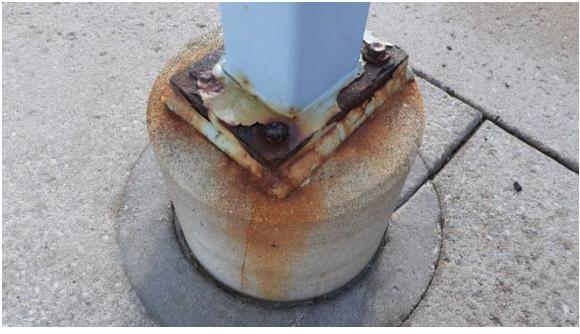
FIGURE 66 – CANOPY BASEPLATES

Canopy baseplates have rust-jacking and corroded. Some bolt heads have completely rusted off. There is a lot of rust staining at the concrete piers. Minor rusting is noted at some tension rods and steel members.

• Canopy can be salvaged; however, it needs to be painted and several of the baseplates will require repair or replacement. However, as noted above, the width of the canopy is not sufficient to protect from the rain, especially where it has increased height.

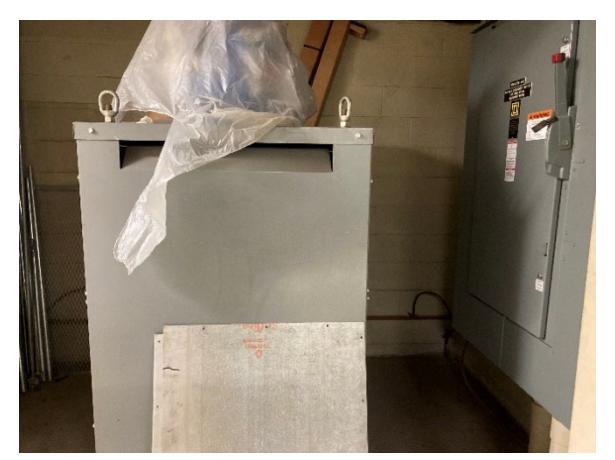
FIGURE 70 - MAIN VAULT ROOM

The layout of Substation MS, the main fire alarm control panel, and the FAA main disconnect does not meet NEC clearance requirements. (Article 110.31 and 110.26A) A redesign of this space is needed to mitigate these code deficiencies.

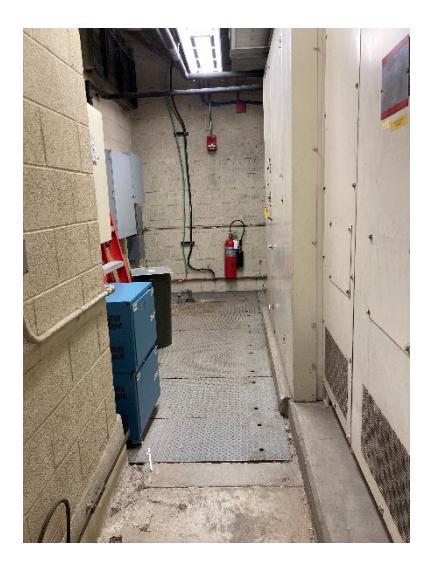
FIGURE 71 – NATIONAL WEATHER SERVICE EQUIPMENT

5. Equipment was incorrectly installed. The installation was never corrected.

A disconnect switch serving National Weather Service equipment was wired backwards. Instead of correcting the problem, a label was put on the switch warning of the incorrect installation

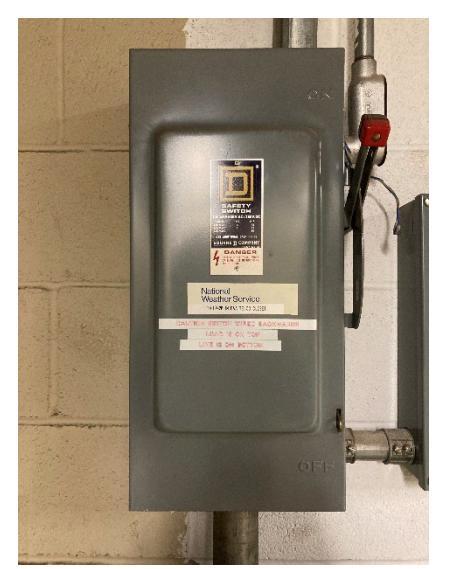
FIGURE 72 – EAST TERMINAL ELECTRICAL EQUIPMENT

6. East Terminal electrical equipment is in fair condition and can be reused.

The equipment installed under the East Terminal Expansion is in fair condition and can be reused for short-term solutions. Due to its age, the equipment requires replacement in 5-7 years.

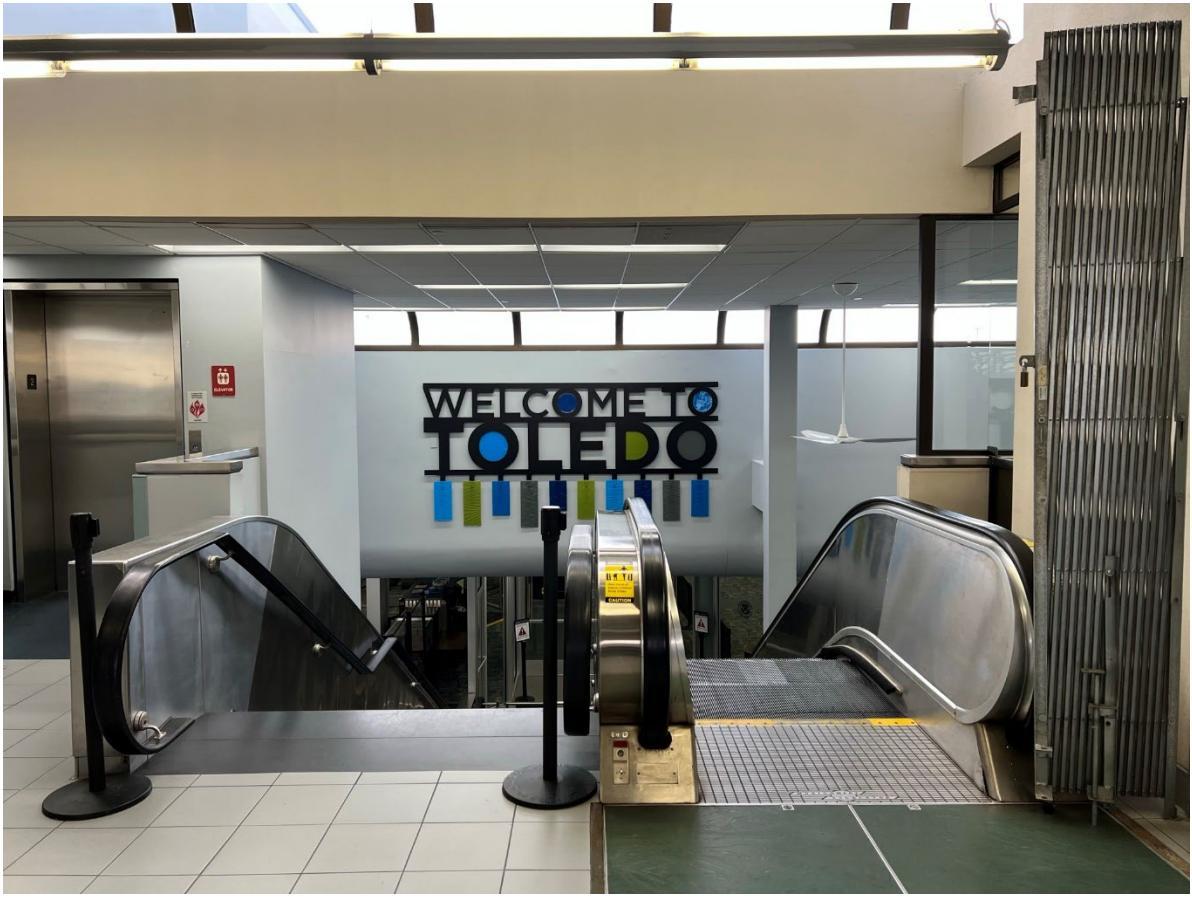
FIGURE 128 – ACCORDION GATE

Accordion gate Holdroom egress is not permitted. The path of egress shall not be interrupted by a building element other than a means of egress component. The accordion gate cannot be used at the stairs as they indicate a path of travel to the exit. It would pose a life safety hazard if it were closed and locked.

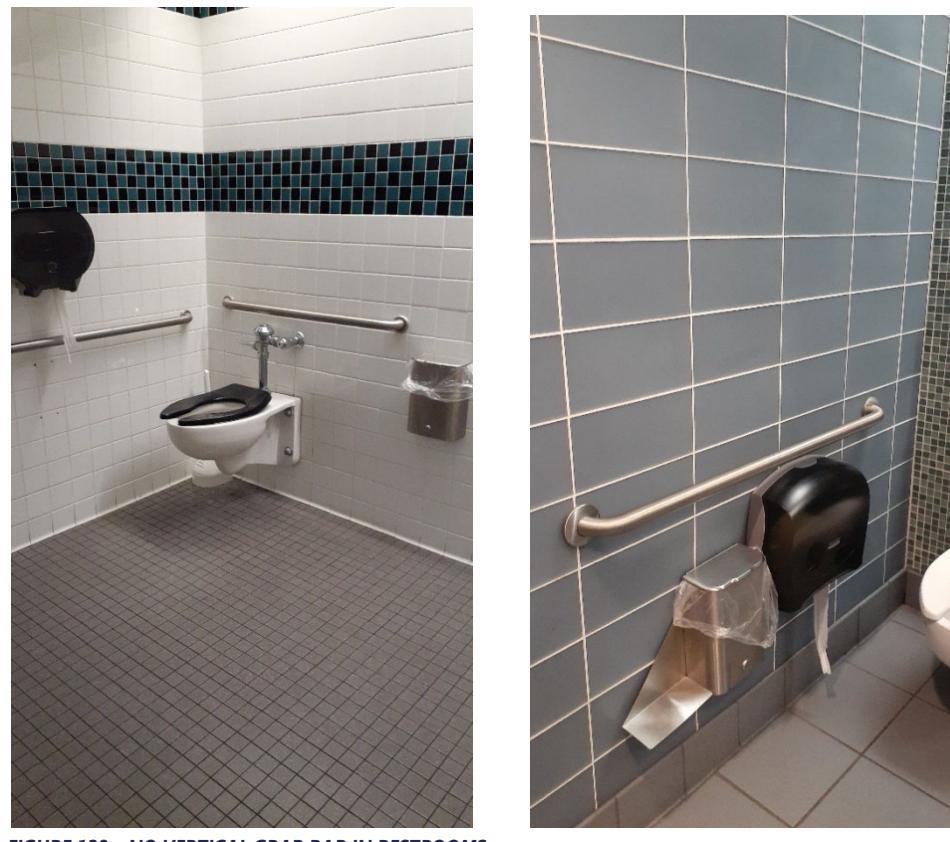
FIGURE 129 - NO VERTICAL GRAB BAR IN RESTROOMS

No vertical grab bar in restrooms per ICC A117.1.

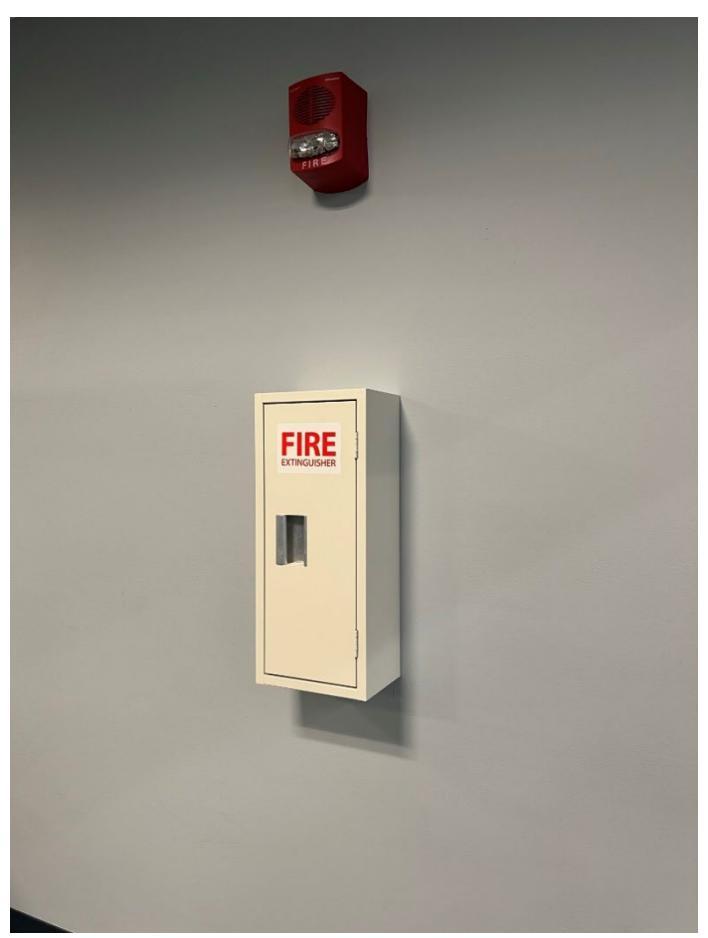
FIGURE 134 – ITEMS PROTRUDING MORE THAN 4"

Wall mounted items create a hazard for the visually impaired. The bottom of an object located more than 27" a.f.f. cannot protrude more than 4" from the wall. Fire extinguisher cabinets protrude beyond 4".

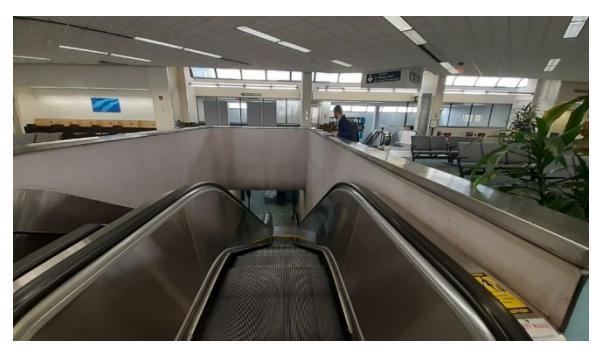
FIGURE 136 - ESCALATOR

ADA references ASME A17.1 Safety Code for Elevators and Escalators. Yellow demarcation along sides and edge of treads at escalator is missing.
