# **Terminal Facility Assessment**

### FINAL

Version 2.0 August 12, 2022 Toledo-Lucas County Port Authority Eugene F. Kranz Toledo Express Airport Swanton, Ohio RS&H No.: 218-1858-012

Prepared by RS&H Ohio, Inc. at the direction of the Toledo-Lucas County Port Authority

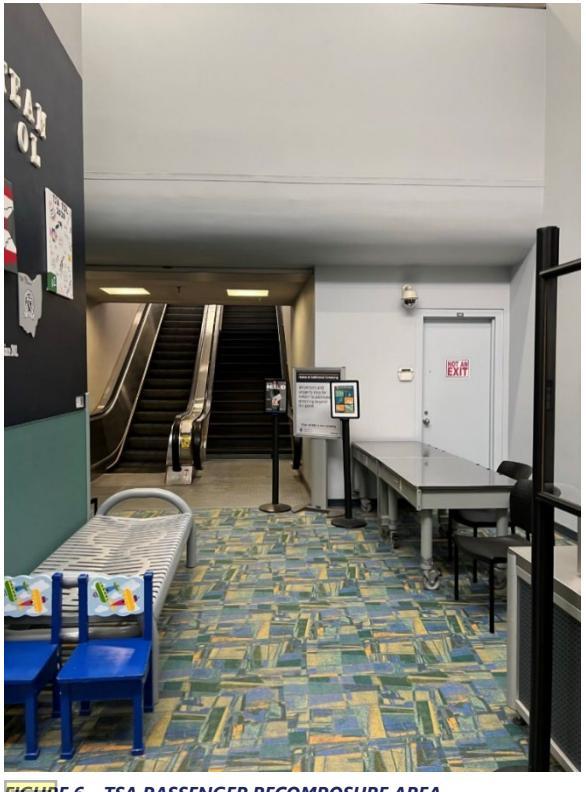
FIGURE 6 – TSA PASSENGER RECOMPOSURE AREA

The following items were found from visual observations or in conversations with staff. There are large expanses of underutilized space and areas that are too condensed or insufficient. An area that does not function properly is the TSA security screening checkpoint, as it overlaps with airline ticketing. As passengers make their way through the screening stages, building columns obstruct the flow, and people with strollers or large bags are instructed to move in a different direction. The area for passengers to remove their shoes and present their items for scanning is tight and does not allow easy passage toward the body scanners. Once through the scanners, the area to pick up belongings is very congested due to the placement of the elevator. There is only one bench available for passengers to put on shoes, and it can become easily blocked by even just one passenger. This causes a delay in the movement of people through the body scanner, as there is no place for them to go. The following examples are areas where adjacent use spaces overlap:

- Queues for Allegiant Airlines check-in and the TSA security checkpoint are intermingled.
- Dining space near the concessions is limited, which causes further congestion in the queue and limits access to the bar area. This forces the dining space to be extended further into the terminal, causing a disconnect with the concessions area. See figures 7 and 8.
- The Concession queue extends to the bar seating area creating inefficiencies in circulation, see figure 9.

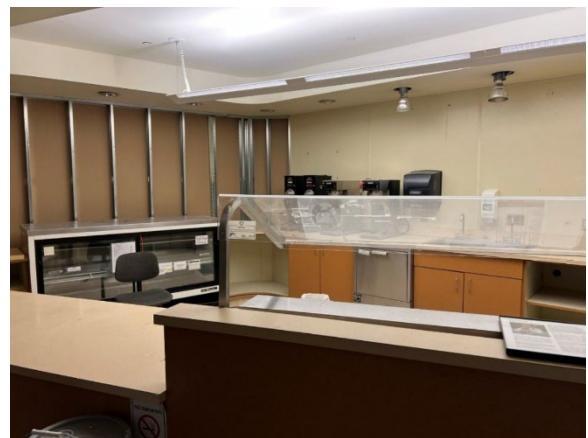
FIGURE 11 – CLOSED RESTAURANT

- The former restaurant space opposite the ticketing counters, see figure 11
- Vacant airline ticketing office (ATO) space, see figures 12 and 13
- Corridor, open area, and restrooms facing airside, located behind the escalators coming from the secure side, see figure 14
- Open area west of the ticketing counters, see figures 15 and 16
- Former offices of the Port Authority Police Station (adjacent to Allegiant), see figure 17
- Both levels of the east holdroom, including restrooms
- West corridor to former gates 1 and 2, associated stairwells, and adjacent space

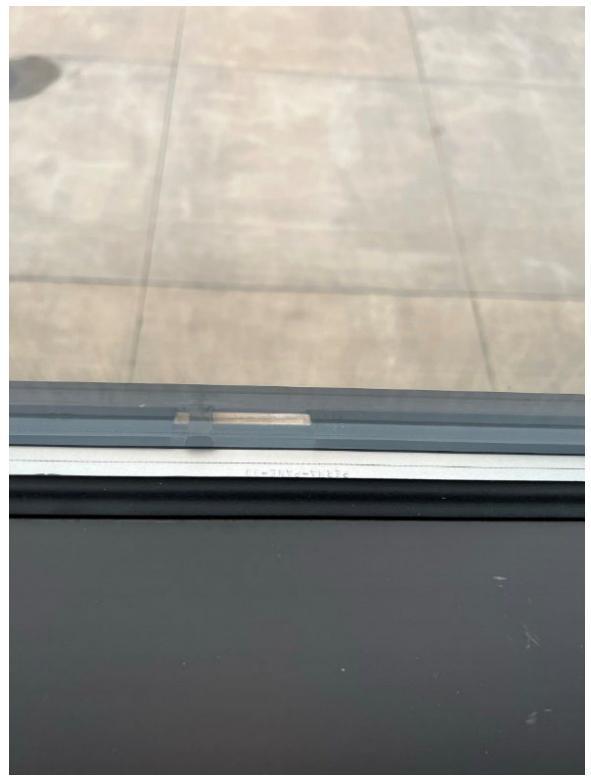
FIGURE 18 - DOUBLE PANED WINDOWS

Sound transmission is a rating of how an interior building element reduces airborne noise from one side to the other. Various interior elements such as walls, floors, ceilings, doors, and windows will transmit sound. The Conference Room and Offices facing the apron consist of double-paned windows and efficiently transmit the sound when aircraft are nearby or taking off on the runways. The high level of sound makes it difficult to function during airplane activity.

STC ratings of the windows and adjacent walls between offices should be increased to provide a
better performing space. Newer insulations, higher STC-rated windows, and sound transmission
barrier products are available that provide greater protection which reduces the transmission of
the airborne noise from adjacent spaces.

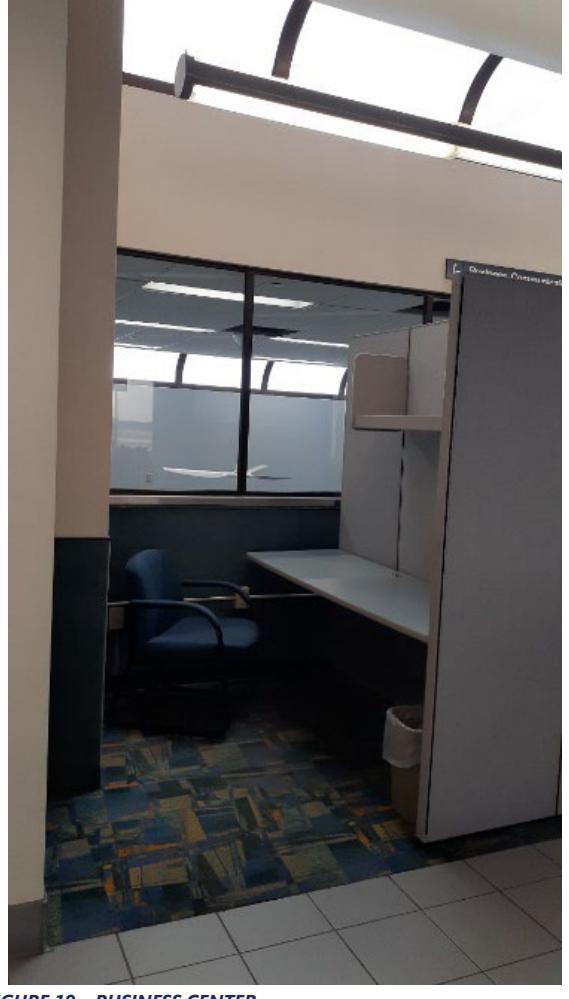
FIGURE 19 – BUSINESS CENTER

Business Center is outdated. No USB/charging ports are provided. Light levels are insufficient. No access to wi-fi.

• It is recommended to provide a Business Center that allows for more sound privacy and updated charging ports.

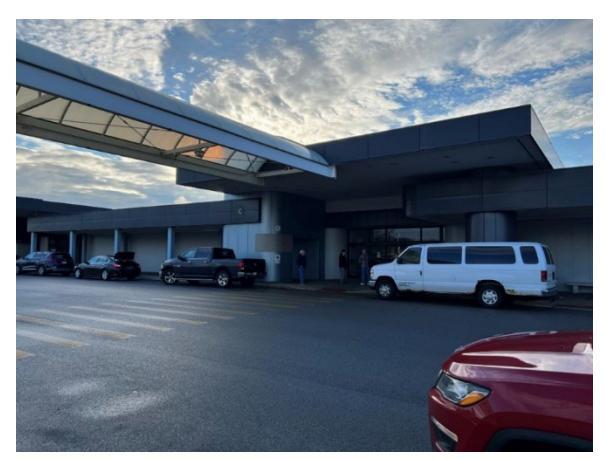
FIGURE 21 – CANOPY FACING TERMINAL

It was observed during heavy rainfall that the canopy leading to the parking lot did not provide any protection from the rain.

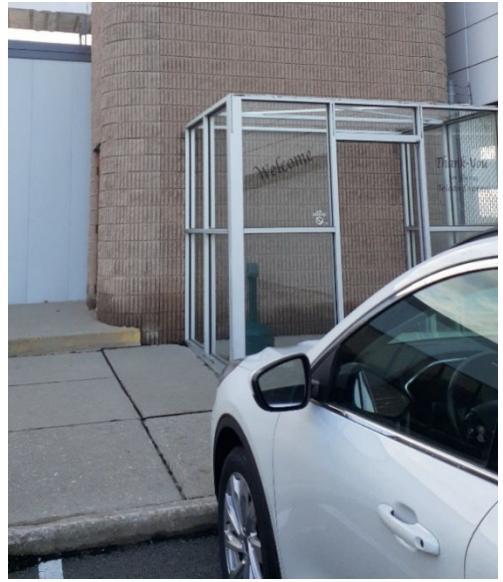
FIGURE 22 – DESIGNATED SMOKING AREA

The Designated Smoking Area is far from the public entry and not used. People were seen smoking near the entrances.

• No smoking signage should be placed at all entries. Additional signage should be placed to indicate the smoking area to occur a minimum of 15' from entry.

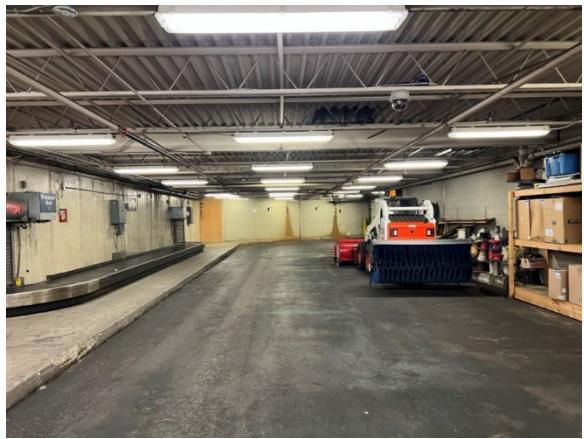
FIGURE 25 – INBOUND BAGGAGE AREA

Snow Removal Equipment (SRE) is often parked at the inbound baggage area, which causes congestion in that space. This suggests that the allocated space for the SRE is inadequate or not in a convenient location.

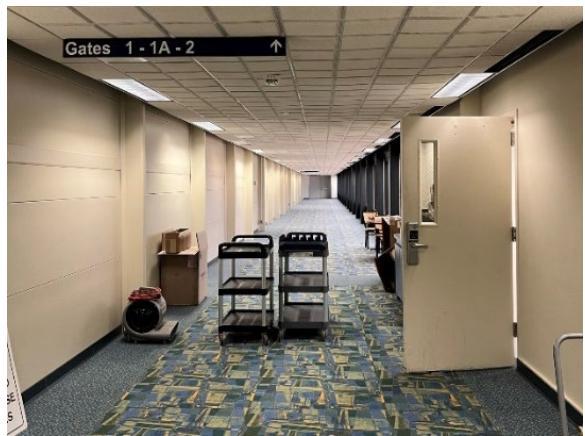
FIGURE 26 - HALLWAY

Some storage is available near the restaurant but is insufficient. Overflow items are kept in the unused hallway to the East Holdroom.

• Restaurant and Concession storage should be increased and relocated so that as items are received from shipment, they can be scanned at security and held in an area closer to where they are readily accessed.

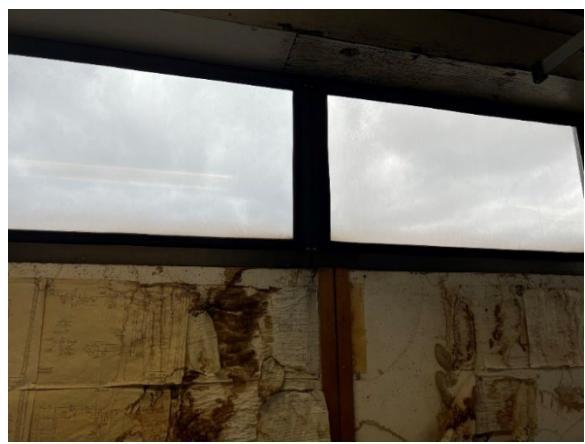
FIGURE 33 – WATER DAMAGE INSIDE TERMINAL

There are many indications throughout the building of water damage due to uninsulated pipes, envelope water infiltration, and perhaps leaks from HVAC and plumbing systems. The water sources are innumerable, and it is unknown, aside from cosmetic damage, if there is mold growth in cavities, chases, or plenums.

• A replacement of the exterior envelope, mechanical, and plumbing systems to rectify the water damage caused throughout would most certainly call for the demolition of the building. At the very least, an extensive renovation would be warranted beyond cosmetic and life cycle needs.

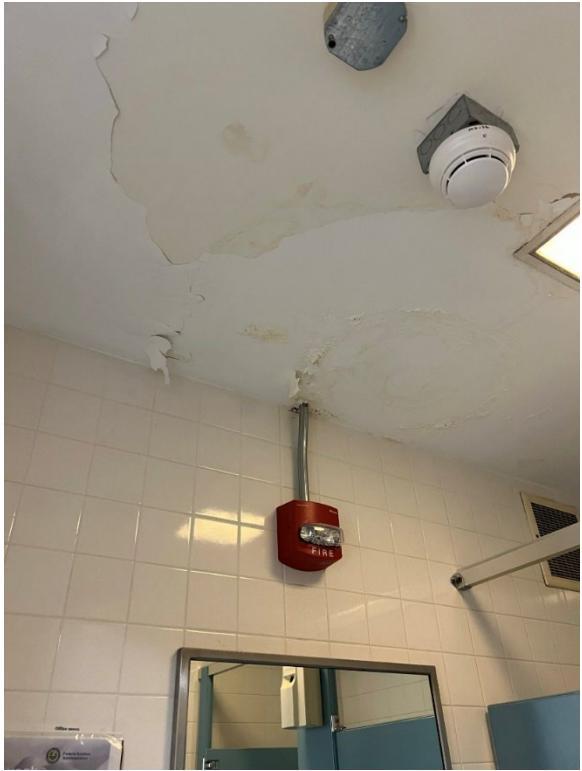
FIGURE 36 - PEELING PAINT

- Inoperable window blinds
- Peeling paint, see figure 36
- Faded/Stained carpet, see figure 37
- Delaminated/chipped countertops/cabinets
- Detached wall base
- Furniture is dated, split vinyl, see figure 38
- Peeling wallpaper, see figure 39
- Light fixtures missing lenses show signs of rust
- Stained/missing acoustical ceiling tile (ACT), see figure 40
- Water damaged drywall
- Aged/stained floor tile
- Trip hazards
  - Electrical cords are taped to the ground, see figure 41
  - o Broken/uneven floor tile, see figure 42
  - o Between floor finishes/missing transition strip, see figure 43
  - Loose gasket at the escalator access panel

It is recommended that all the finishes in the passenger terminal facility are replaced.
### 1.3.1.14 Inbound Baggage

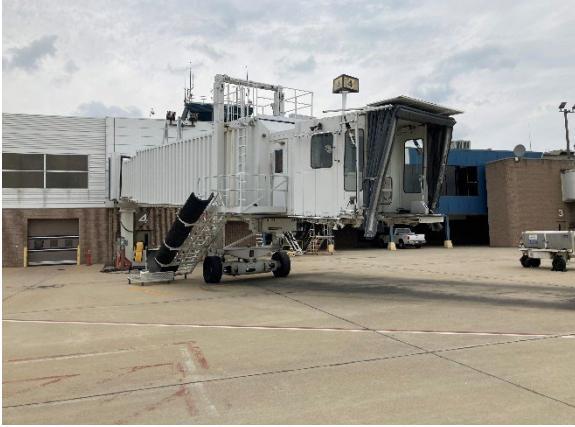
FIGURE 48 – PASSENGER BOARDING BRIDGE – GATE 4

The passenger terminal currently has four passenger boarding bridges (PBB) at gates 2, and 3-5. Gate 2 is in the east holdroom, while gates 3-5 are in the main terminal. The devices at gates 2, 3, and 5 are operational, while the device at gate 4 is inoperable. Gates 3 and 5 are used most often, while gate 2 is used during irregular operations only.

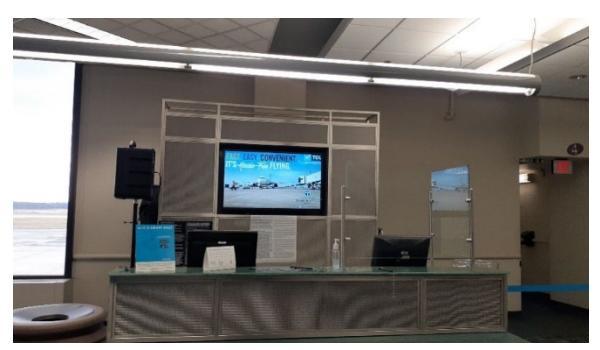
FIGURE 50 – AIRLINE GATE PA SYSTEM

The public address system (PA) system for the airlines in the passenger terminal is inoperable. They are currently using portable speakers.

• A new PA system should be provided for the use of the airlines.

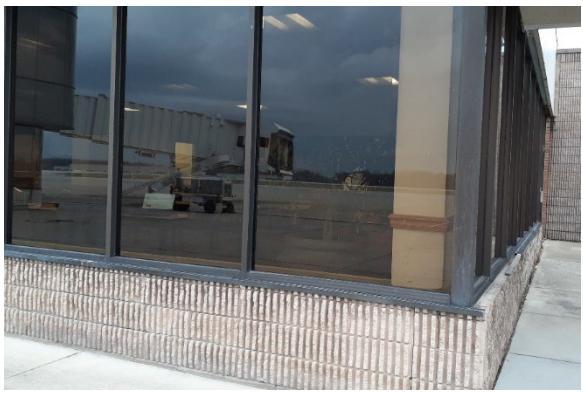
FIGURE 51 – BUILDING ENVELOPE

The biggest issues are caused by the water infiltration that is occurring all over the building envelope. These are also the costliest. These components exhibit signs of water infiltration, abuse, and overall end of useful life:

- Ribbed concrete panels-some cracks visible, dark areas at the base of panels which is indicative of water at interior. No base flashing was visible, see figure 40
- Missing windowsill/flashing, see figure 50
- Deteriorated concrete sill at storefront glazing system, see figure 41
- Rusted column enclosures, figures 51 and 52
- Peeling paint, including on columns, metal exterior doors, and guardrails, see figure 53
- Loading dock damage, see figure 54
- Rusted coping, including soft spots at roof cover board, figure 55
- Cracked concrete base at column due to storm sewer water freeze/thaw cycle, figure 56
- Expansion joint failure
- No lightning protection

All the ceilings and soffits are recommended for complete demolition. Areas, where water was detected, may require additional repairs, and should be further inspected for a full scope of select demolition.

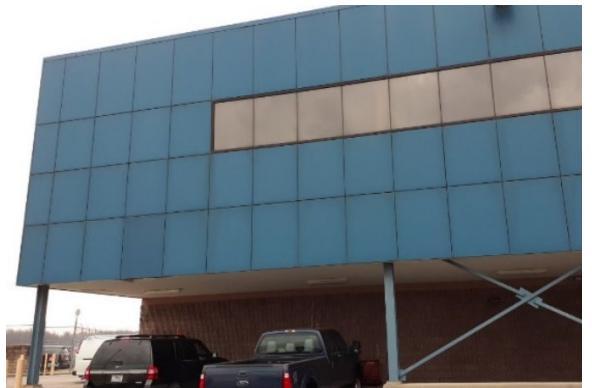
FIGURE 60 - METAL WALL PANELS

The exterior metal panels are showing the following signs of needing replacement:

- Dark areas at individual panel perimeters exhibits infiltration from missing, loose, or failed gaskets (attempted repairs with sealant)
- Evidence of rust
- Caulking at base of metal panels does not allow water to drain
- Gaps/detached flashing at metal panels on roof
- Patches with sealant
- Exterior soffits exhibit history of patching adjacent to metal panels

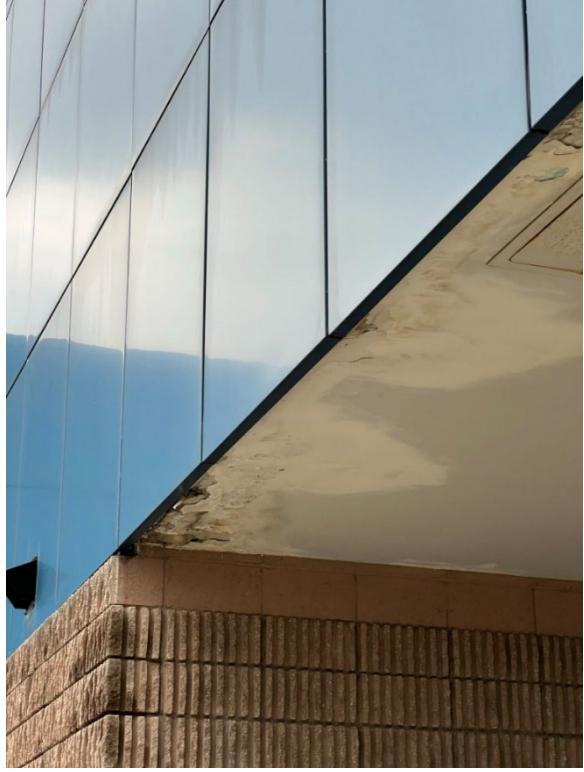
FIGURE 62 - WATER DAMAGE

Water damage has begun to affect the interior finish components and has resulted in notable organic growth, staining, and damage in many areas.

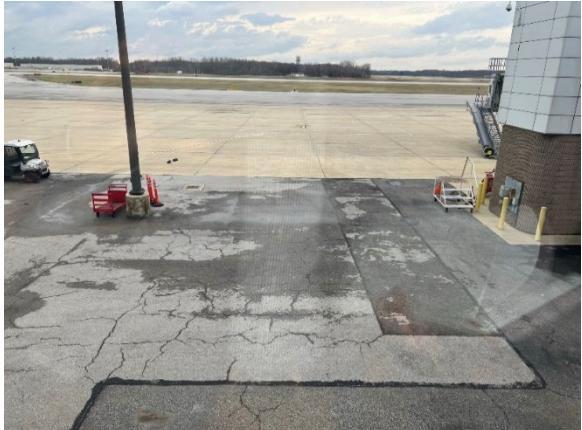
FIGURE 67 – AIRSIDE CONCRETE

- Airside concrete pavement is in good condition
- Airside asphalt has some cracks without noticeable upheaval

• Pavement is in good condition and can remain for future use.

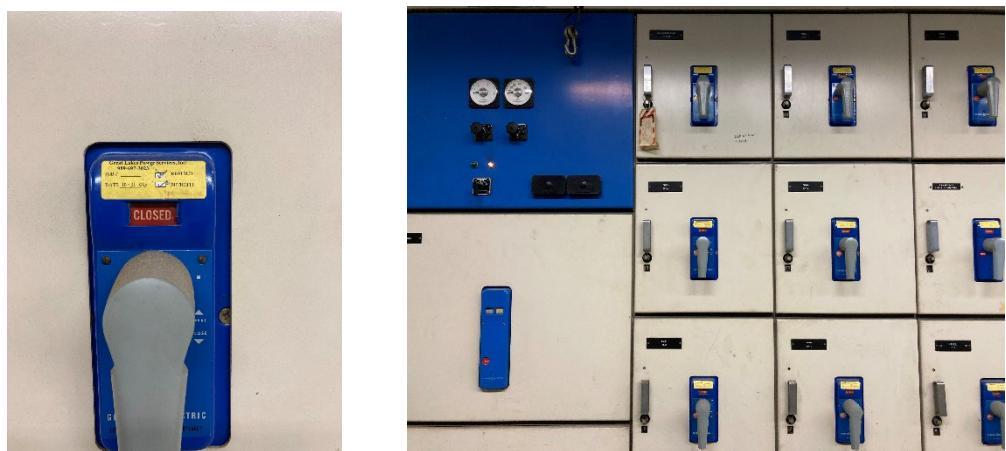
FIGURE 69 – ATCT AND MAIN TERMINAL DISTRIBUTION EQUIPMENT

- 1. Over 50% of the ATCT and Main Terminal's distribution equipment should be replaced immediately or within the next 5-7 years.
- 2. Substation MS is of particular concern. Circuit breaker parts are no longer made requiring a retrofit of circuit breakers. Consequently, any future breaker failure and the extended time needed to obtain a replacement breaker will impact airport operations.
- 3. The Terminal main vault room contains numerous code violations.

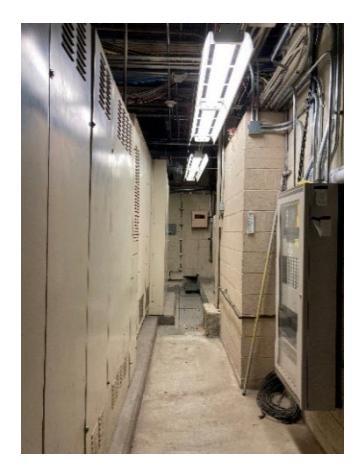
4. The main vault room is subject to flooding.

Given the presence of medium voltage (15,000 volts), this condition is extremely dangerous. This necessitated the installation of a sump pit next to the substation lineup.

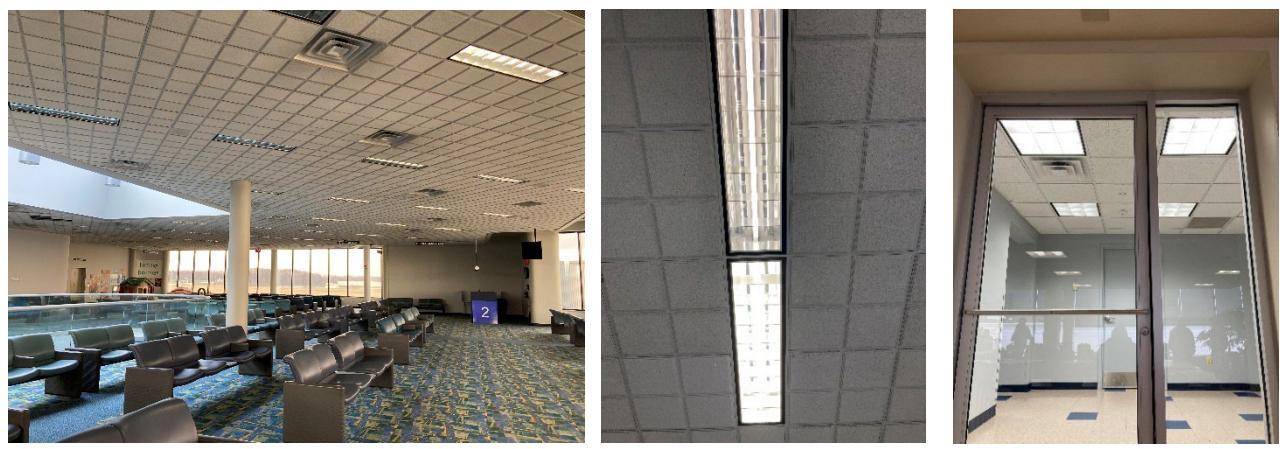
FIGURE 73 – TERMINAL LIGHTING

The Main Terminal, East Terminal, and the ATCT interior lighting consists of luminaires utilizing mostly fluorescent sources. Some luminaires were retrofitted with specular reflectors to increase light out and

lumen efficacy. In either case, the energy efficiency of these systems does not match the output and efficiency of the latest LED technology. All fluorescent based luminaires will need to be replaced. Lighting in the airport administration area utilizes LED sources. These fixtures can be reused. (See Figure 70)

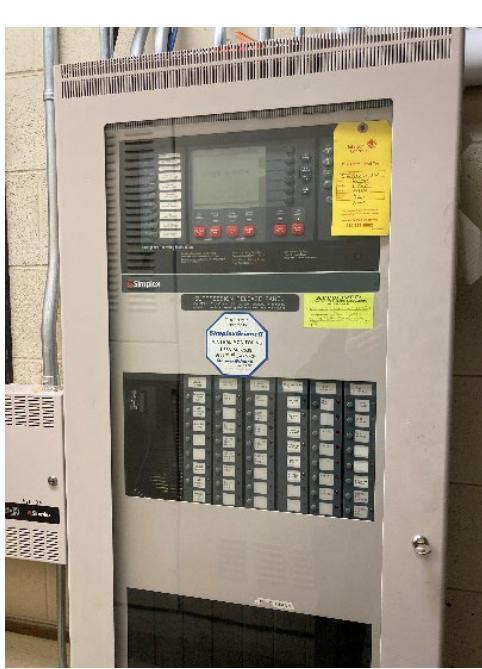
FIGURE 74 – FIRE ALARM SYSTEM

The Main Terminal fire alarm system was upgraded in 2007 to a Simplex 4100U addressable platform. (see Figure 71) New control panel, initiation and notification devices were installed in the Main Terminal, East Terminal and ATCT. In 2017, an additional upgrade occurred in the ATCT. The system is in good condition and can be reused.

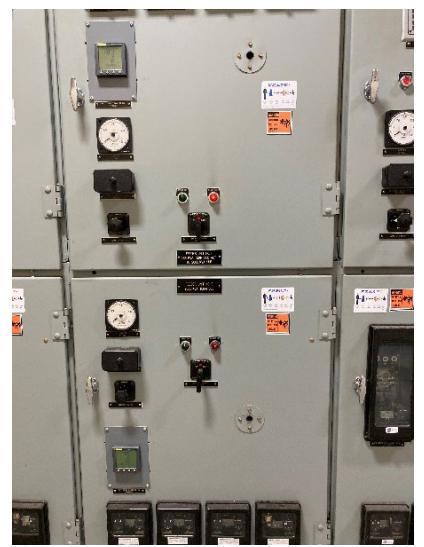
FIGURE 75 – AIRFIELD VAULT SUBSTATION

As indicated previously, the incoming service to the Main Terminal is derived from a double ended, 15 KV substation located in the Airfield Vault Building. The substation is in good condition. (see Figure 75). The provision of dual feeders to the main terminal provides additional electric service redundancy. This concept and its associated equipment should be reused. A 300KW diesel generator and associated automatic transfer switch (ATS) supports the airfield lighting. The generator, ATS, and associated distribution equipment is in good condition and can be reused.

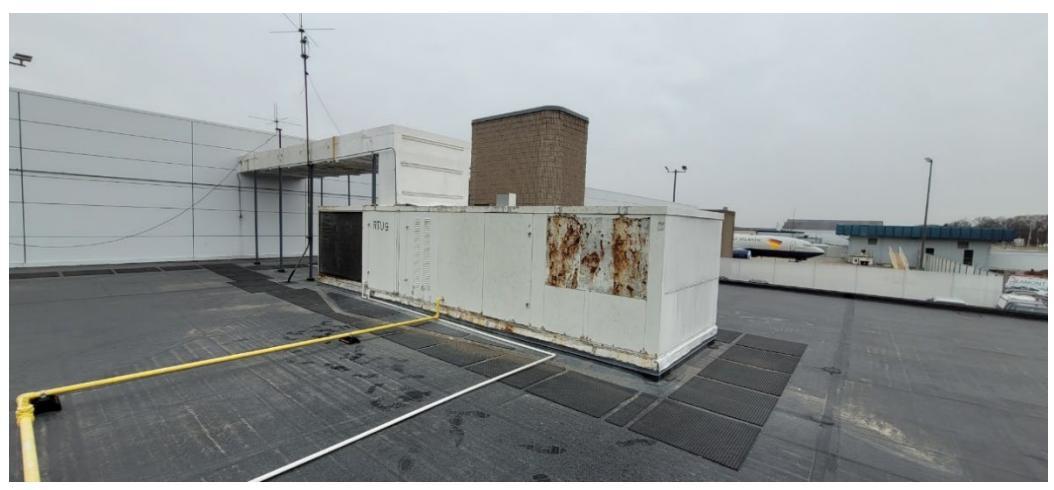
FIGURE 80 - RTU 14 CONDENSING UNIT INSTALLED IN 1979

RTU-14	Roof CU   AHU ATCT Level 3	Trane Climate Changer	1979	8.5	4	Replace	20	-23	1999	Unit(s) in poor condition serving Level 3 of ATCT. AHU damper and valves manually operated. Both AHU and condensing unit very rusted. Replacement of unit(s) recommended.			
RTU-15	Roof   First Floor East	York Sunline D2CG	1999	25	4	Replace	20	-3	2019	Unit in poor operating and visual condition. Unit near end of useful life. Replacement of unit recommended.			
RTU-16	Roof   Second Floor East	York Millennium	1999	40	4	Replace	20	-3	2019	Unit in poor operating and visual condition. Unit near end of useful life. Replacement of unit recommended.			
RTU-17	Roof   Banquet Room	Trane Voyager	2003	15	3/4	Maintain/Replace	20	1	2023	Unit in fair operating and visual condition. Continue regular general maintenance per manufacturers recommendations until end of useful life.			
RTU-18	Roof   In-Flight Kitchen, Offices	Trane Voyager	2003	20	3/4	Maintain/Replace	20	1	2023	Unit in fair operating and visual condition. Continue regular general maintenance per manufacturers recommendations until end of useful life.

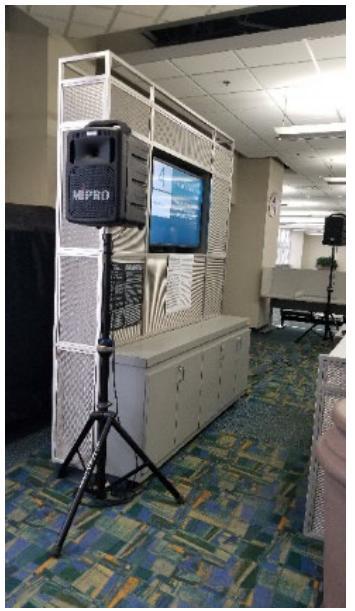
FIGURE 106 – GATE COUNTER WITH SPEAKER ON A STAND

- At present, the PA system in the Airport is not working. There are no prerecorded public announcements, specific pages from the gate counters, or background music playing.
- The existing analog speakers are found throughout the terminal areas, including baggage claim, ticketing, and concourse holdrooms, etc.
• One of the gate counters uses a speaker on a stand for boarding-related announcements, as shown below.

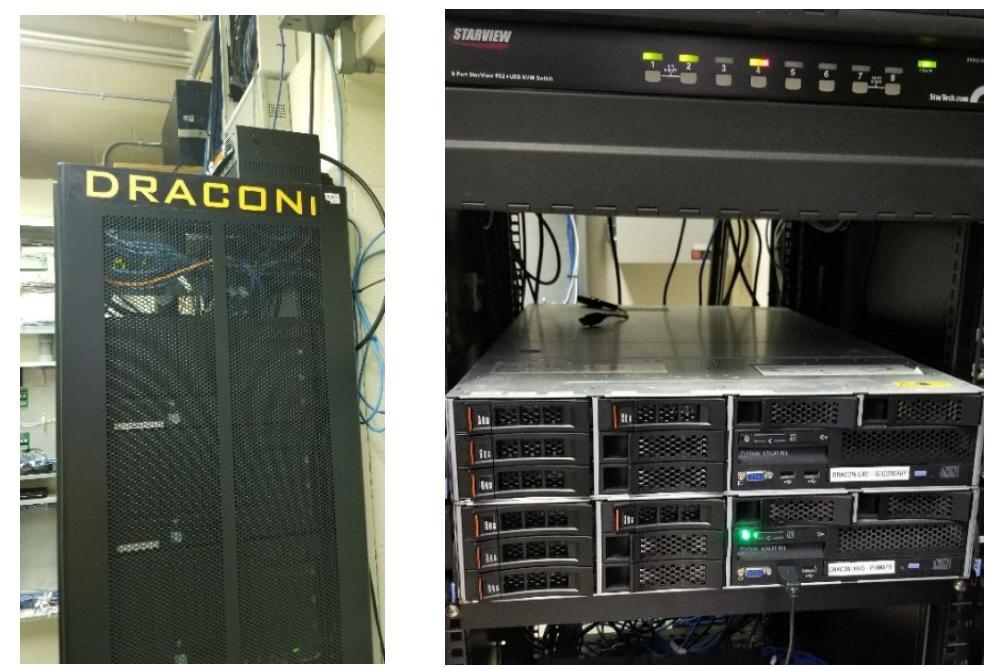
FIGURE 112 – ACCESS CONTROL CABINET WITH DRACONI EQUIPMENT

- The existing ACS is made by DRACONi and the headend equipment is located in the MCR. The system is not reliable due to the end of useful life and lack of technical support from the manufacturer. A local electrical firm maintains the system.

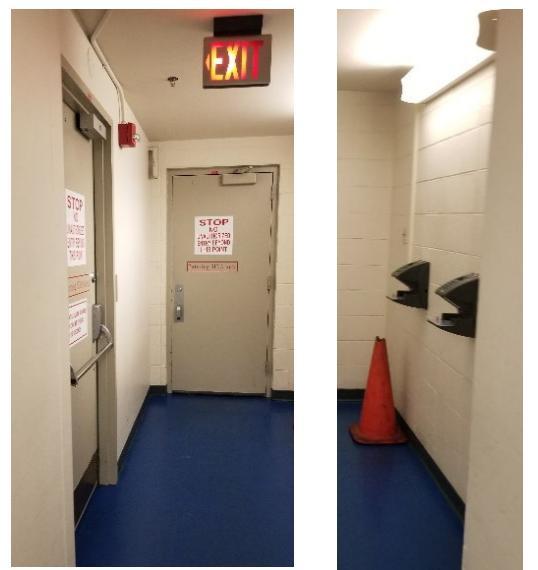
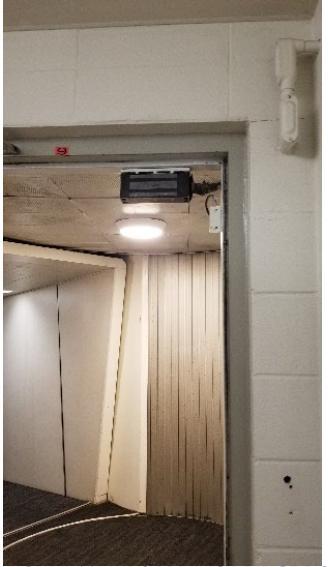
FIGURE 113 – STERILE SIDE OF EGRESS AND BOARDING BRIDGE DOORS

FIGURE 114 – BOARDING BRIDGE DOOR WHEN OPENED

• The doors on the sterile (public) sides are in good condition, whereas the back of house (or secured) side doors were found to be in poor condition.

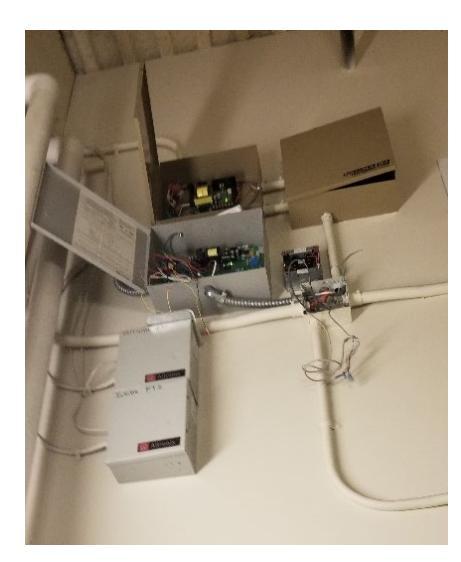
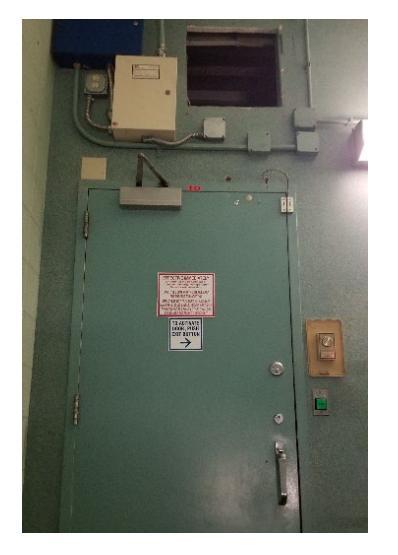
FIGURE 115 - ACCESS CONTROL ENCLOSURE ON THE SECURE SIDE OF THE DOOR

#### FIGURE 116 – SECURE SIDE OF ACCESS CONTROLLED DOOR

The access control field panels are located above the door or nearby electrical rooms. The field
panels are made by Securitron (ASSA ABLOY), and the door power supplies are made by Altronix<sup>®</sup>.
Some of the field panels at the stair tower are in bad condition and the panel covers are opened or
missing.

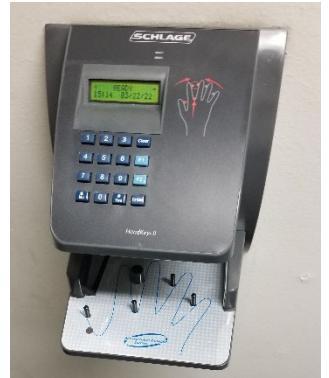
• The card reader used in the Airport is Schlage's HandKey 2, consisting of contactless card readers and finger/palm readers. The reader is having problems reading the finger/palm print and requires two or three attempts for successful read to enter through the secured door/portals. (TOL is willing to replace existing biometric card reader, Schlage HandKey 2, with the contactless card readers).

FIGURE 118 – EXISTING 2-FACTOR CARD READER

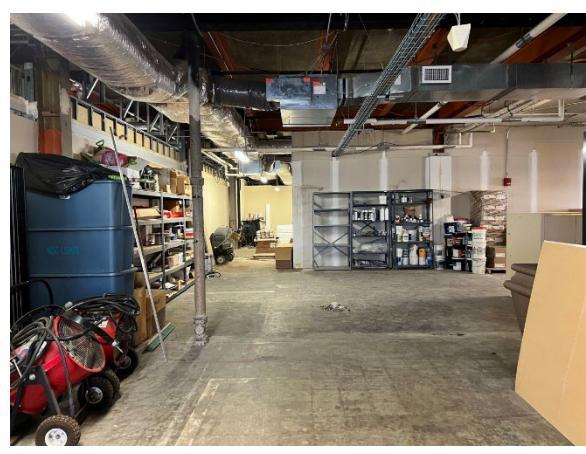
Due to the various Use Groups, fire-rated partitions are required for separation. Although these separations may have existed, but due to typical maintenance, installation or removal of wiring, wall mounted items, etc. penetrations have been made. These penetrations will not have had the proper protective fire-stopping required to maintain the fire-rated assembly.

FIGURE 125 – STORAGE ON FIRST FLOOR

- First floor storage at far west end was not initially intended as storage
- Commercial Kitchen and all adjacent occupancies
- Office Areas (Business Occupancy) and Terminal (Assembly Occupancy)
- Baggage Make-up (Low Hazard Occupancy) and Office (Business Occupancy)
- Smoke Barrier passageway at ATCT
- A thorough examination of the space use allocation should be done to determine where fire separations, both vertically and horizontally, should occur. Proper fire penetrative materials should be applied at both existing and new penetrations to provide protection.

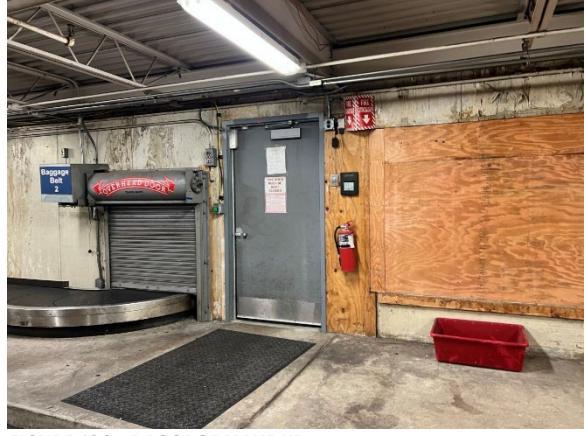
FIGURE 126 – BAGGAGE MAKE UP

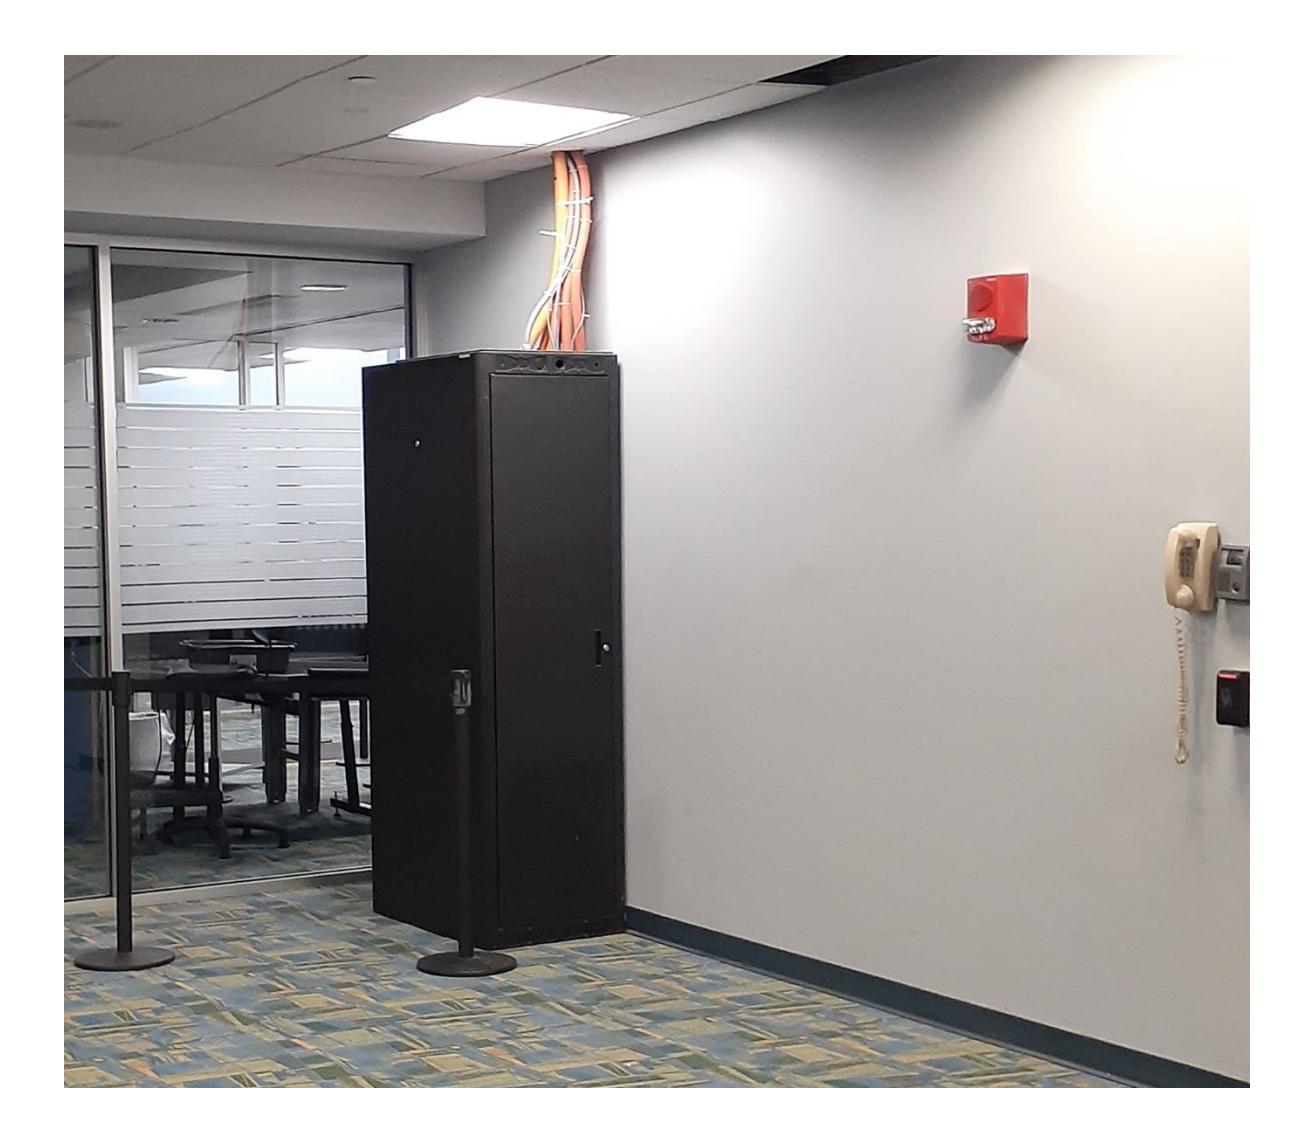
In the ticketing area, adjacent to the queue for the TSA security checkpoint, the cables for the control tower are exposed. This leaves operations of the Airport and the overall safety of the flights at risk.

#### FIGURE 127 – EXPOSED CABLES

• Cables leading to the ATCT should be encased in a rated shaft wall, protected from fire, penetrations, and in general, public access.

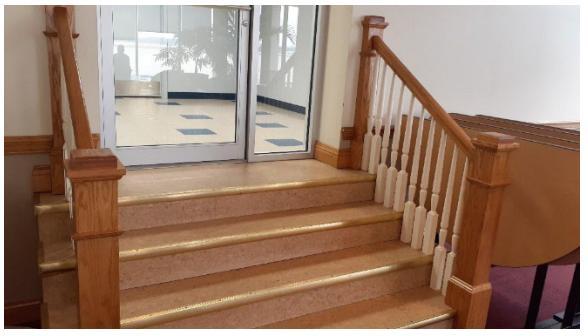
Landing at the Conference room is insufficient. Landings are required to be at a minimum depth of 44" in the direction of travel. Doors in the fully open position shall not reduce a required dimension by more than 7". Handrails at the same stairs are not compliant as they do not have the required extension at the bottom of the stairs.

FIGURE 130 – STAIRWAY LANDING

• Since the door swings into the room, a 36" door requires the landing to be 77" deep in the direction of travel. This will require a reconfiguration of the door, landing, stairs, and handrails.

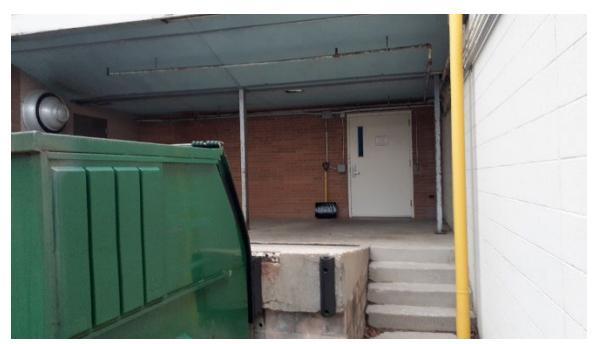
Loading dock handrail is not present. Handrails are required at all stairways, including the loading docks.

FIGURE 131 – LOADING DOCK

• Provide a handrail on each side of the stairway.

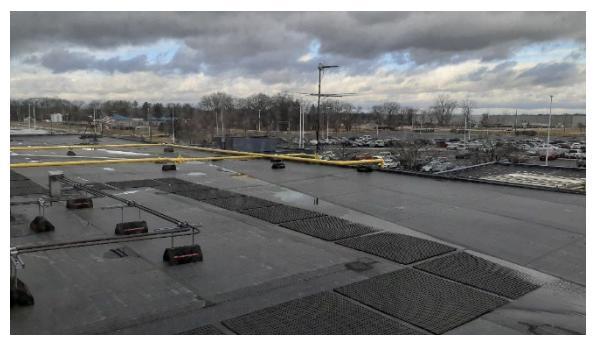
FIGURE 132 – TERMINAL ROOF

• The roof was reported to have been replaced approximately 5 years ago. However, a new roofing system will require to meet IECC. To meet the IECC R value requirements, additional insulation will be necessary which in some cases will require the roof edge or parapets to be raised. This may affect adjacent materials, electrical, heating, cooling, and other systems.

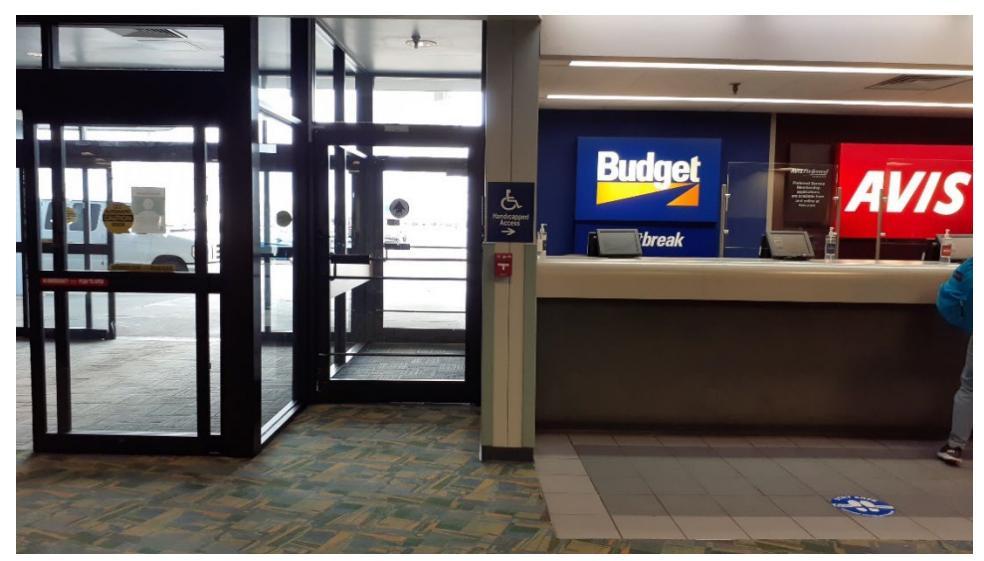
Some signs which have ADA requirements are worn, or out of compliance.

FIGURE 133 - EXIT DOORS

• Exit doors at discharge and exit stairways are required to be identified by tactile signs. Required wayfinding signs need to be updated with current ADA standards.

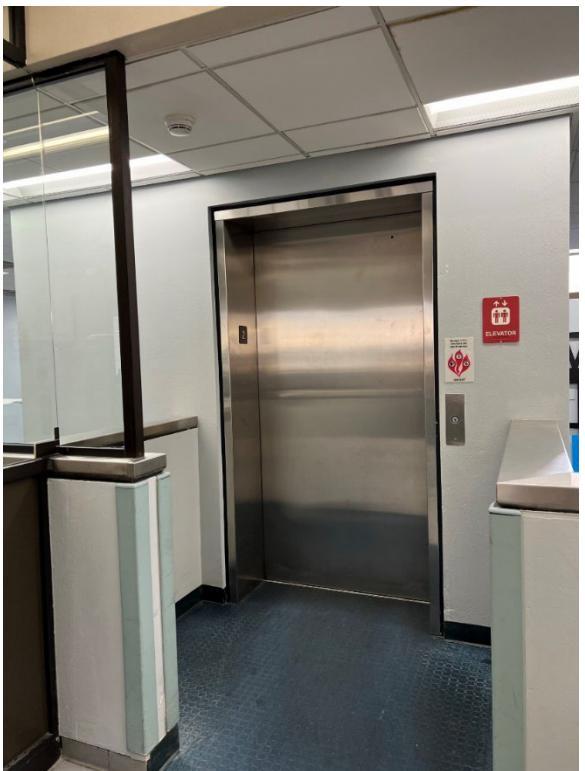
- Visible hall signal car indicator.
- No audible signal for the arrival
- No verbal announcement of a stop
- No audible signals (one for up and two for down or annunciator)
- Reopening the device without physical contact
- Emergency communication per ASME A17.1

#### FIGURE 135 - ELEVATOR

• The elevator cab needs to be updated to be ADA compliant.

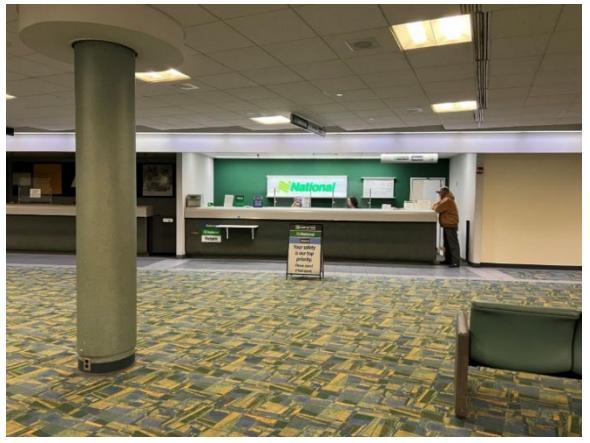
Standing space at fixed counters, such as at the car rentals counters, do not have an accessible work counter. At least 5% of the standing spaces shall be accessible. Only National has an added shelf at a lowered counter, designated as accessible. However, this does not allow for the exchange of services and money because the service counter behind it is tall. This additional shelf requires a person to reach even further.

FIGURE 137 – RENTAL CAR COUNTERS

• Provide an accessible counter at all service counters.

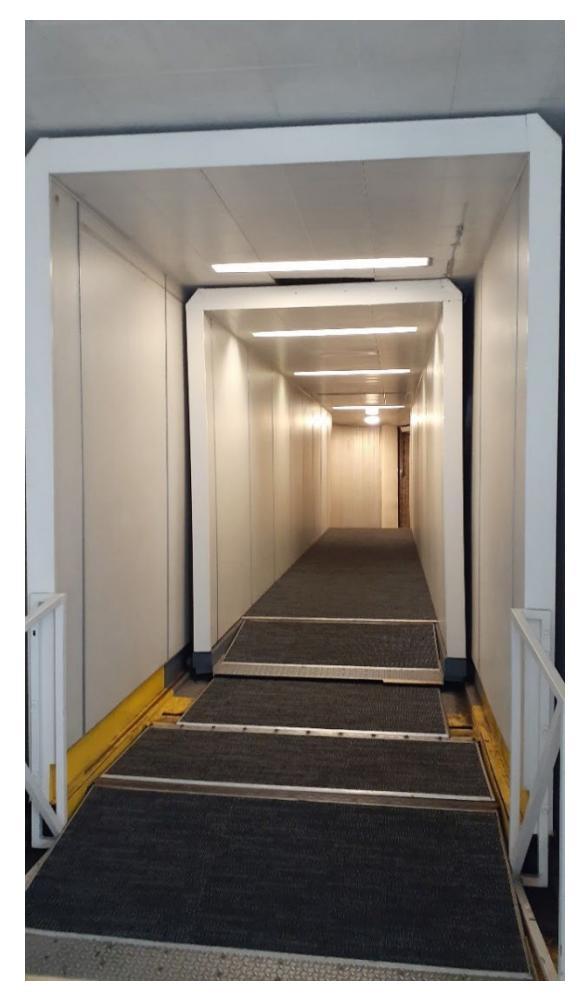
- Slope exceeds 1:12
- No handrails or improper handrail extensions
- Inadequate landings between sloped areas

FIGURE 138 – PASSENGER BOARDING BRIDGE

• Three of the PBB's are antiquated and non-compliant. One is inoperable, and the other two are older should be replaced. The fourth PBB, gate 5, a 2017 ThyssenKrupp model, appears to be in good operating condition and compliant.

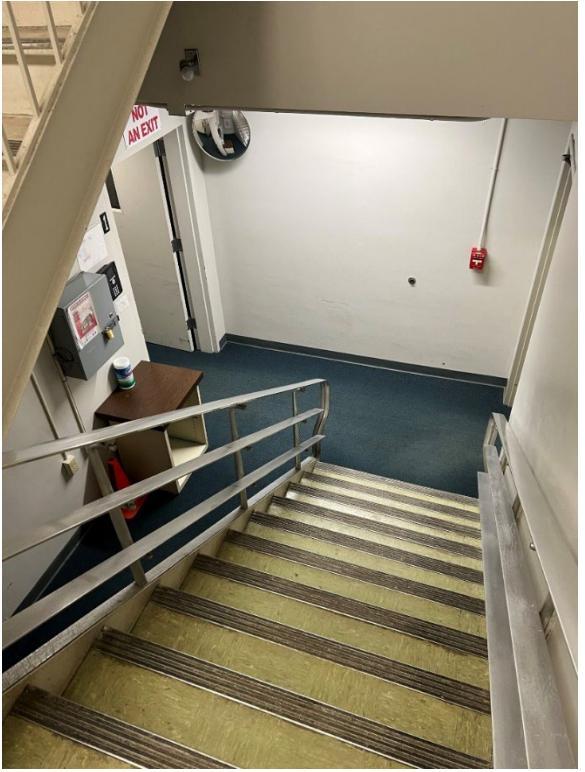
- Stair landing at the conference room is insufficient. It is required to be 48" in length.
- Handrails at exit stairwell in office area do not have a compliant cross-section. Cross-section of handrails cannot exceed 2 1/4".
- Handrails at the conference room & Port Authority office stairs
- Handrails ramp to offices/stairwells do not have the required 12" extension at the top and bottom of the ramp.

FIGURE 139 – STAIRWELL

• Handrails should be replaced to provide proper lengths, diameters, and extensions. In some cases, blocking will need to be provided where handrails require extension.

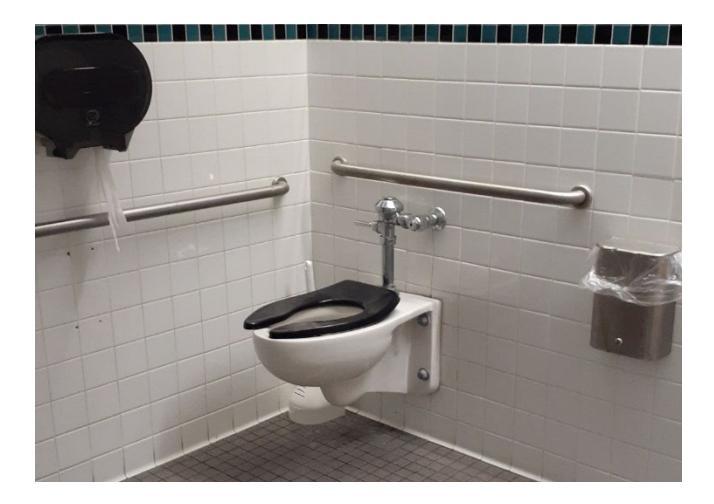
#### FIGURE 140 – FLUSH CONTROL ON TOILET

• Flush controls for toilet must be on the open side. Flush control is located on the side nearest the wall.

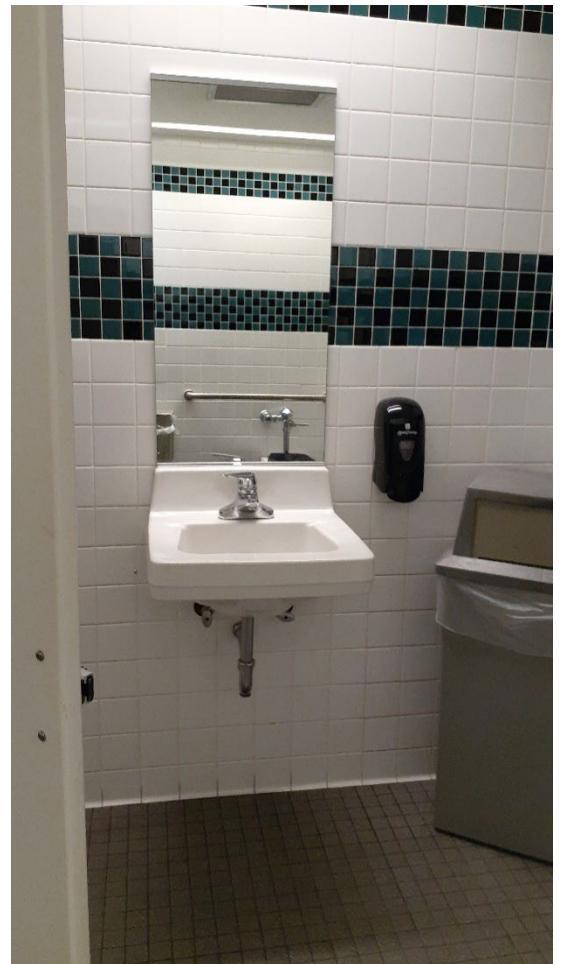
FIGURE 141 – ACCESSIBLE SINK

- No pipe protector at sink in an accessible toilet stall
- The tissue dispenser requires 12" min. clearance above the grab bar.
- The soap dispenser in an accessible stall does not have compliant floor clearance due to trash receptacle.
- The top of the side grab bar is less than 33" a.f.f.

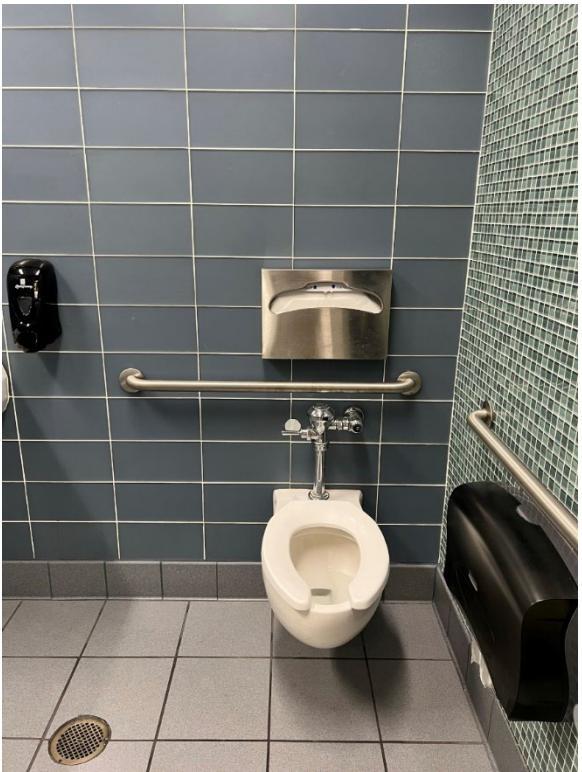
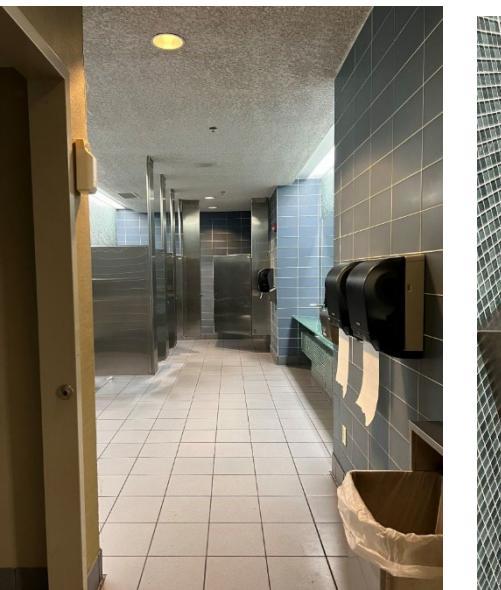
- Toilet seat cover dispenser within 12" above the rear grab bar
- The paper towel dispenser projects more than 4" from the wall.

FIGURE 142 – SECOND FLOOR PUBLIC RESTROOM

FIGURE 143 – PAPER TOWEL DISPENSER IN RESTROOM

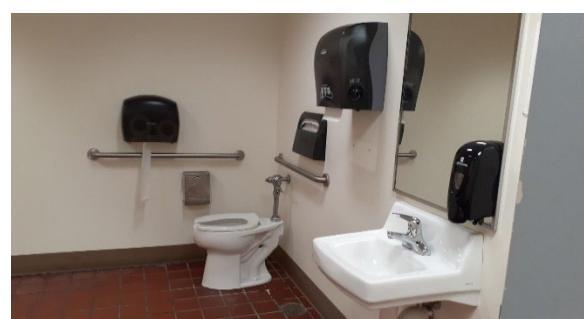
• Tissue and toilet seat cover dispensers require 12" min. clearance above the grab bar.

FIGURE 144 – FIRST FLOOR ADMINISTRATION RESTROOM

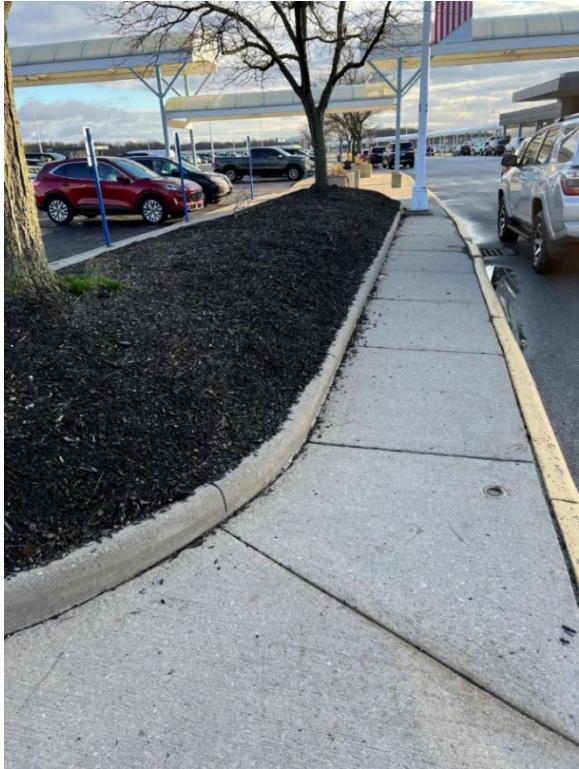
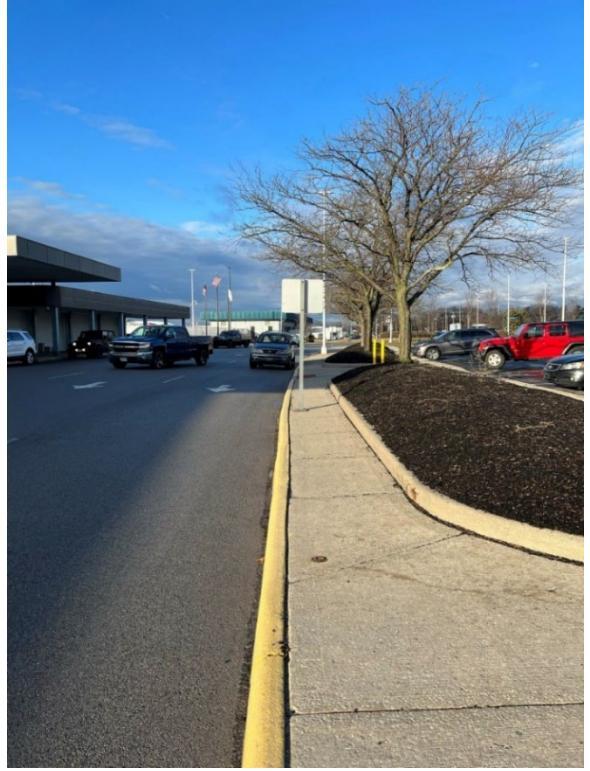
Portions of the sidewalk have light fixtures/signs which reduce the path.

FIGURE 145 – PARKING LOT SIDEWALK FACING EAST

FIGURE 146 – PARKING LOT SIDEWALK FACING WEST

• Sidewalks should provide an accessible path. Poles, signs, and other obstructions should be relocated.
